# Access Compliance Report Public Rights-of-Way (Curb Ramps)

Main Street: N/A Cross Street: LA\_COLINA\_DR Location: W

ADA ID: RPRK220125115015 Ramp Type: Type 1 - Perpendicular Diagonal Initial Pass/Fail: Fail Overall Compliance: No Severity Score: 45

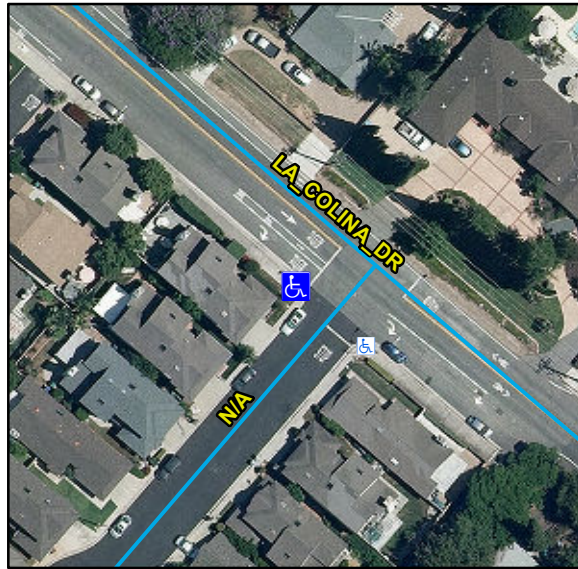
| Compliance | Description | Data | Compliance | Description | Data |
|---|---|---|---|---|---|
| No | Ramp Run Slope (%) | 13.1 | N/A | Flare Slope LT (%) | N/A |
| No | Ramp Cross Slope (%) | 5.1 | N/A | Flare Traversable LT | N/A |
| No | Gutter Lip Height (in) | 0.25 | | Road Run Slope (%) | 2.7 |

**Remove & Replace Curb Ramp With Two New Directional Ramps or Equivalent. Grind Gutter Lip.**

**R204.3, R304.2.2, R304.5.3, R302.7.2, STD 1115**
