# Access Compliance Report Public Rights-of-Way (Curb Ramps)

Main Street: LA\_COLINA\_DR Cross Street: N/A Location: S

ADA ID: RPRK220125115251 Ramp Type: Type 1 - Perpendicular Diagonal Initial Pass/Fail: Fail Overall Compliance: No Severity Score: 45

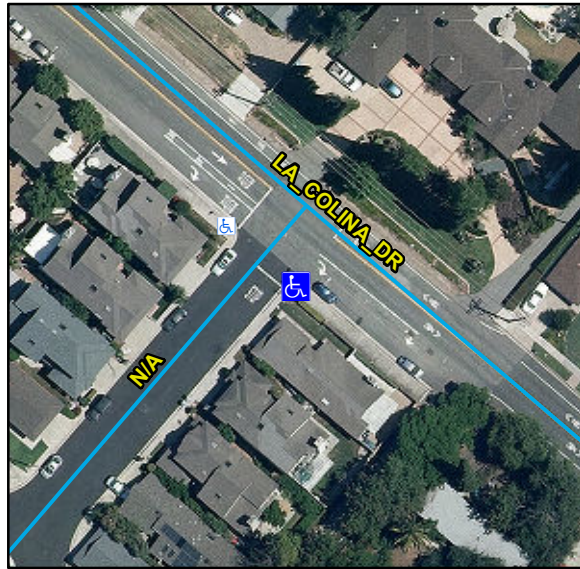
| Compliance | Description | Data | Compliance | Description | Data |
|---|---|---|---|---|---|
| No | Ramp Run Slope (%) | 13.2 | N/A | Flare Slope LT (%) | N/A |
| No | Ramp Cross Slope (%) | 6.8 | N/A | Flare Traversable LT | N/A |
| No | Gutter Lip Height (in) | 0.5 | | Road Run Slope (%) | 1.7 |

**Remove & Replace Curb Ramp With Two New Directional Ramps or Equivalent. Grind Gutter Lip.**
