# Access Compliance Report Public Rights-of-Way (Curb Ramps)

Main Street: NEWPORT\_AVE Cross Street: VANDERLIP\_AVE Location: W

ADA ID: RPRK220125115827 Ramp Type: Type 4 - Parallel Initial Pass/Fail: Fail Overall Compliance: No Severity Score: 2

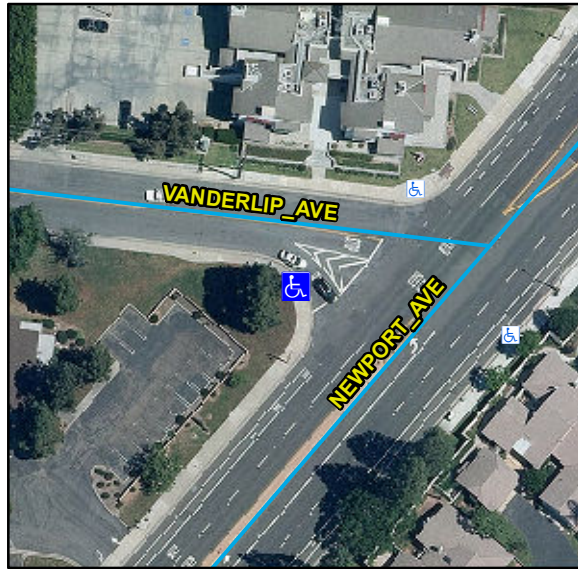
| Compliance | Description | Data | Compliance | Description | Data |
|---|---|---|---|---|---|
| No | Ramp Cross Slope LT (%) | 3.1 | No | Ramp Cross Slope RT (%) | 2.3 |

Remove & Replace Curb Ramp With Two New Directional Ramps or Equivalent.

R304.5.3, STD 1115
