# Access Compliance Report Public Rights-of-Way (Curb Ramps)

Main Street: SANDERSTEAD\_RD Cross Street: HOLT\_AVE Location: S

ADA ID: RPRK220125121558 Ramp Type: Type 1 - Perpendicular Initial Pass/Fail: Pass Overall Compliance: No Severity Score: 20

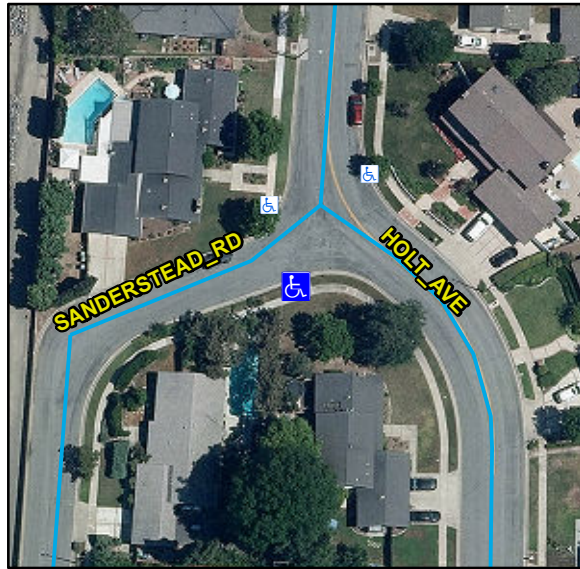
| Compliance | Description | Data | Compliance | Description | Data |
|---|---|---|---|---|---|
| No | Landing Run Slope (%) | 5.4 | N/A | Flare Traversable RT | No |
| No | Landing Cross Slope (%) | 2.1 | No | DWS Provided | No |
| No | Gutter Run Slope (%) | 5.8 | | Road Cross Slope (%) | N/A |

Remove & Replace Entire Ramp. Remove & Replace Gutter.
