# Access Compliance Report Public Rights-of-Way (Curb Ramps)

Main Street: SANDERSTEAD\_RD Cross Street: HOLT\_AVE Location: NW

ADA ID: RPRK220125121855 Ramp Type: Type 7 - Directional 2 Initial Pass/Fail: Fail Overall Compliance: No Severity Score: 2

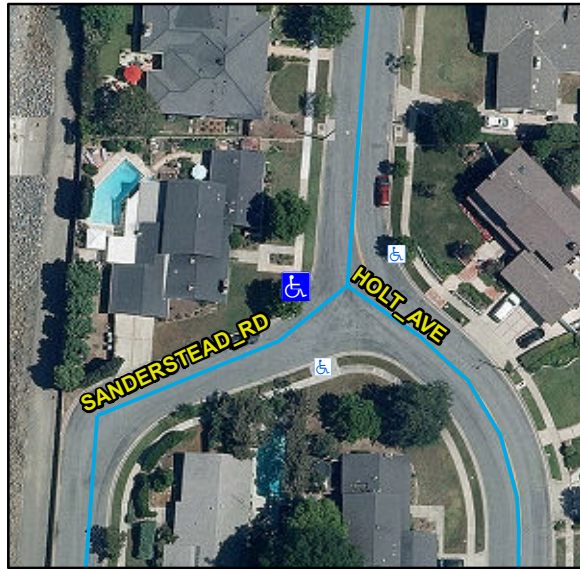
| Compliance | Description | Data | Compliance | Description | Data |
|---|---|---|---|---|---|
| No | Ramp Cross Slope (%) | 4.9 | N/A | Flare Traversable LT | N/A |

Remove & Replace Entire Ramp.

R304.5.3, STD 1115
