# Access Compliance Report Public Rights-of-Way (Curb Ramps)

Main Street: 17TH\_ST Cross Street: GERSHON\_PL Location: NW

ADA ID: RPRK220125122546 Ramp Type: Type 4 - Parallel Initial Pass/Fail: Pass Overall Compliance: No Severity Score: 0

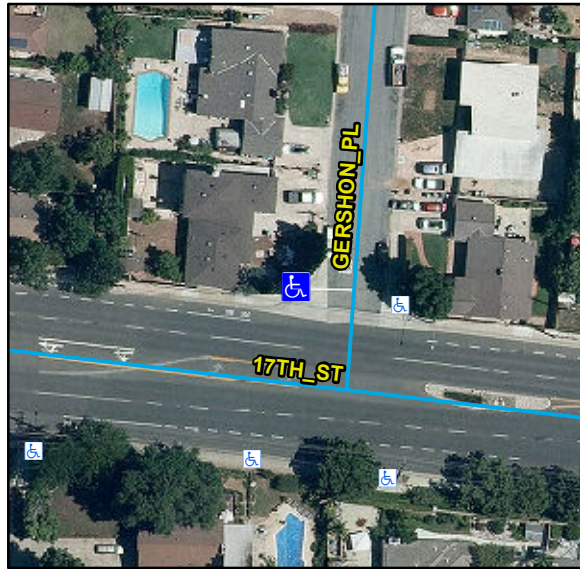
| Compliance | Description | Data | Compliance | Description | Data |
|---|---|---|---|---|---|
| No | Gutter Cross Slope (%) | 3 | Yes | Perpendicular Joint Present | Yes |

Remove & Replace Gutter.

R304.5.3, STD 1115
