# Access Compliance Report Public Rights-of-Way (Curb Ramps)

Main Street: GERSHON\_PL Cross Street: 17TH\_ST Location: NE

ADA ID: RPRK220125123057 Ramp Type: Type 4 - Parallel Initial Pass/Fail: Fail Overall Compliance: No Severity Score: 2

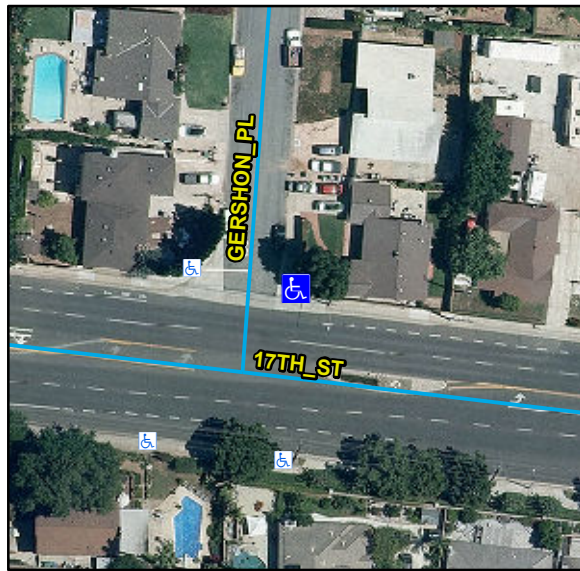
| Compliance | Description | Data | Compliance | Description | Data |
|---|---|---|---|---|---|
| Yes | Ramp Cross Slope LT (%) | 0.9 | No | Ramp Cross Slope RT (%) | 3.9 |

Remove & Replace Curb Ramp With Two New Directional Ramps or Equivalent.

R304.5.3, STD 1115
