# Access Compliance Report Public Rights-of-Way (Curb Ramps)

Main Street: 17TH\_ST Cross Street: BRENNAN\_WAY Location: NW

ADA ID: RPRK220125123706 Ramp Type: Type 4 - Parallel Initial Pass/Fail: Fail Overall Compliance: No Severity Score: 2

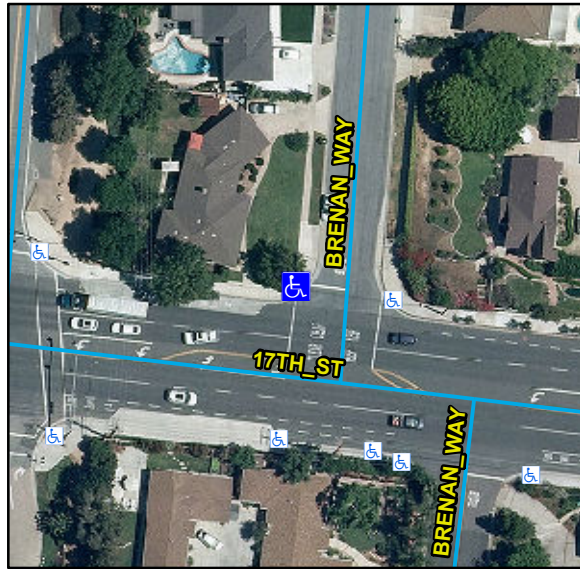
| Compliance | Description | Data | Compliance | Description | Data |
|---|---|---|---|---|---|
| No | Ramp Cross Slope LT (%) | 3.5 | No | Ramp Cross Slope RT (%) | 2.3 |

**Remove & Replace Curb Ramp With Two New Directional Ramps or Equivalent.**

**R304.5.3, STD 1115**

Total Cost: \$ 4000
