# Access Compliance Report Public Rights-of-Way (Curb Ramps)

Main Street: **BRENAN\_WAY** Cross Street: **17TH\_ST** Location: **NE**

ADA ID: **RPRK220125124005** Ramp Type: **Type 4 - Parallel** Initial Pass/Fail: **Fail** Overall Compliance: **No** Severity Score: **2**

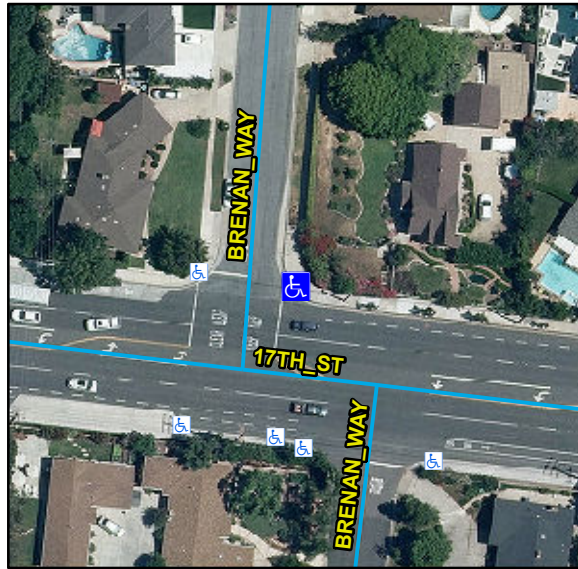
| Compliance | Description | Data | Compliance | Description | Data |
|---|---|---|---|---|---|
| <b>No</b> | Ramp Cross Slope LT (%) | <b>3.3</b> | <b>No</b> | Ramp Cross Slope RT (%) | <b>4</b> |

**Remove & Replace Curb Ramp With Two New Directional Ramps or Equivalent.**

**R304.5.3, STD 1115**
