# Access Compliance Report Public Rights-of-Way (Curb Ramps)

Main Street: AUBURN\_AVE Cross Street: BRENAN\_WAY Location: S

ADA ID: RPRK220125124241 Ramp Type: Type 4 - Parallel Initial Pass/Fail: Fail Overall Compliance: No Severity Score: 16

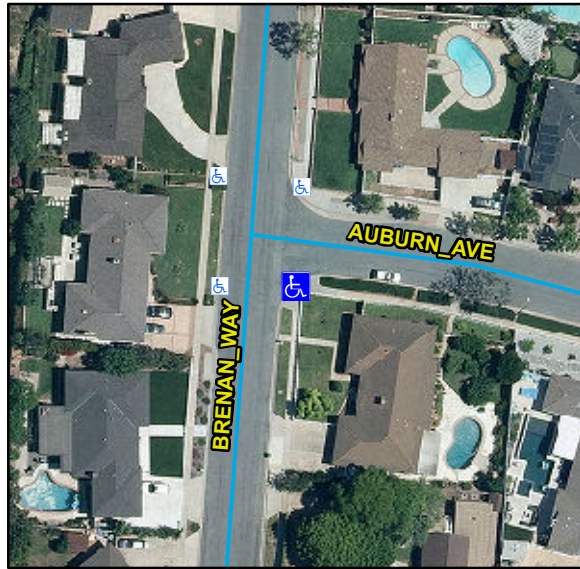
| Compliance | Description | Data | Compliance | Description | Data |
|---|---|---|---|---|---|
| No | Ramp Run Slope LT (%) | 8.4 | Yes | Ramp Run Slope RT (%) | 4.6 |
| Yes | Ramp Cross Slope LT (%) | 1 | No | Ramp Cross Slope RT (%) | 4.2 |

Remove & Replace Curb Ramp With Two New Directional Ramps or Equivalent.

R304.3.2, R304.5.3, STD 1115
