# Access Compliance Report Public Rights-of-Way (Curb Ramps)

Main Street: BEACHMONT\_AVE Cross Street: BRENAN\_WAY Location: S

ADA ID: RPRK220125124602 Ramp Type: Type 4 - Parallel Initial Pass/Fail: Fail Overall Compliance: No Severity Score: 32

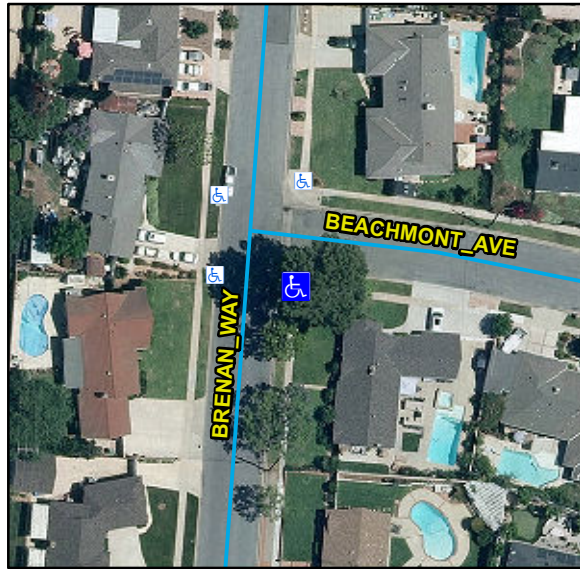
| Compliance | Description | Data | Compliance | Description | Data |
|---|---|---|---|---|---|
| No | Ramp Run Slope LT (%) | 8.4 | Yes | Ramp Run Slope RT (%) | 3.3 |
| No | Ramp Cross Slope LT (%) | 3.2 | Yes | Ramp Cross Slope RT (%) | 1.5 |
| No | Gutter Lip Height (in) | 1 | | Road Run Slope (%) | 2.1 |
| No | Overall Surface Condition | Poor | | | |

**Remove & Replace Curb Ramp With Two New Directional Ramps or Equivalent. Grind Gutter Lip.**

**R204.3, R304.3.2, R304.5.3, R302.7, R302.7.2, STD 1115**
