# Access Compliance Report Public Rights-of-Way (Curb Ramps)

Main Street: **BRENAN\_WAY** Cross Street: **BEACHMONT\_AVE** Location: **E**

ADA ID: **RPRK220125125012** Ramp Type: **Type 4 - Parallel** Initial Pass/Fail: **Fail** Overall Compliance: **No** Severity Score: **2**

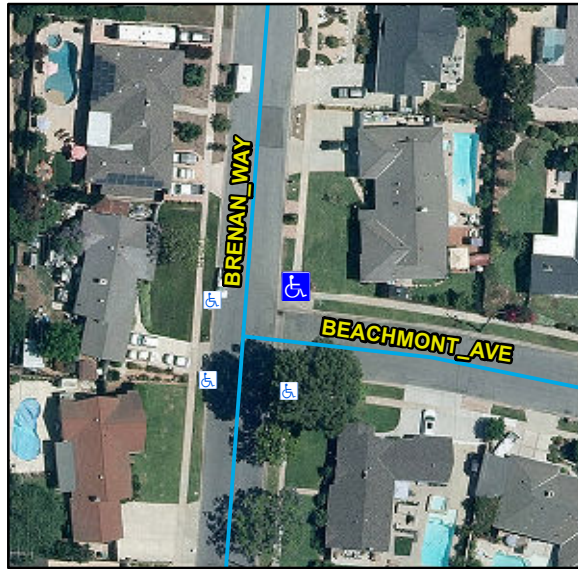
| Compliance | Description | Data | Compliance | Description | Data |
|---|---|---|---|---|---|
| <b>No</b> | Ramp Cross Slope LT (%) | <b>2.8</b> | <b>No</b> | Ramp Cross Slope RT (%) | <b>3.2</b> |

**Remove & Replace Curb Ramp With Two New Directional Ramps or Equivalent.**

**R204.3, R304.5.3, STD 1115**
