# Access Compliance Report Public Rights-of-Way (Curb Ramps)

Main Street: HEATHER\_GLEN Cross Street: HEWES\_AVE Location: S

ADA ID: RPRK220125130514 Ramp Type: Type 4 - Parallel Initial Pass/Fail: Fail Overall Compliance: No Severity Score: 2

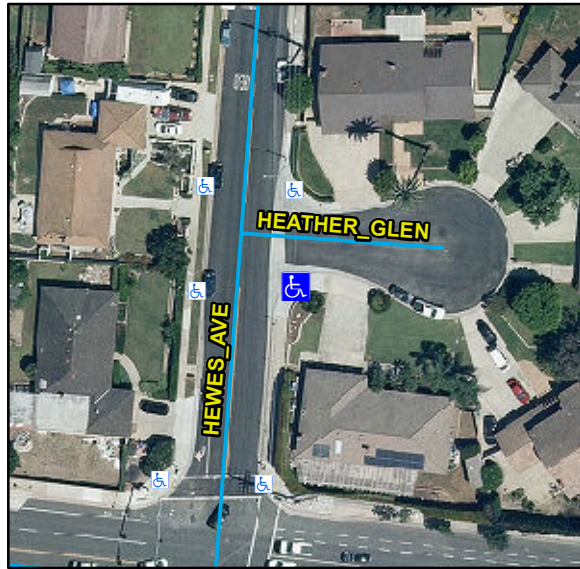
| Compliance | Description | Data | Compliance | Description | Data |
|---|---|---|---|---|---|
| No | Ramp Cross Slope LT (%) | 3.5 | No | Ramp Cross Slope RT (%) | 3.6 |

Remove & Replace Curb Ramp With Two New Directional Ramps or Equivalent.

R304.5.3, STD 1115
