# Access Compliance Report Public Rights-of-Way (Curb Ramps)

Main Street: HEWES\_AVE Cross Street: HEATHER\_GLEN Location: E

ADA ID: RPRK220125130755 Ramp Type: Type 4 - Parallel Initial Pass/Fail: Fail Overall Compliance: No Severity Score: 16

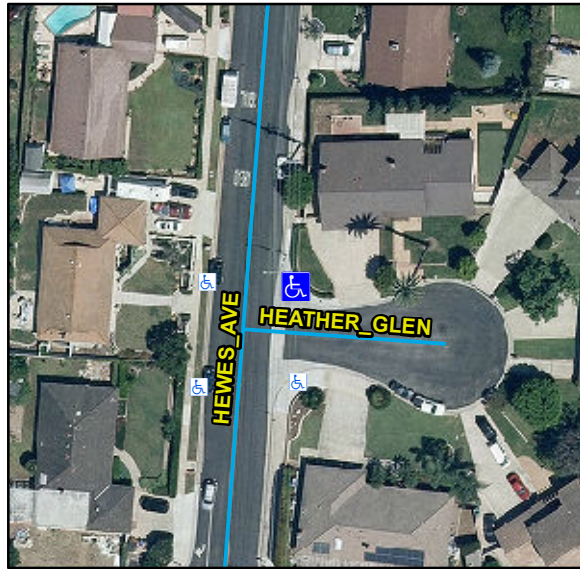
| Compliance | Description | Data | Compliance | Description | Data |
|---|---|---|---|---|---|
| Yes | Ramp Run Slope LT (%) | 7.4 | No | Ramp Run Slope RT (%) | 8.6 |

**Remove & Replace Curb Ramp With Two New Directional Ramps or Equivalent.**

**R304.3.2, STD 1115**

Total Cost: \$ 4000
