# Access Compliance Report Public Rights-of-Way (Curb Ramps)

Main Street: N/A Cross Street: 17TH\_ST Location: SW

ADA ID: RPRK220125131340 Ramp Type: Type 4 - Parallel Initial Pass/Fail: Fail Overall Compliance: No Severity Score: 2

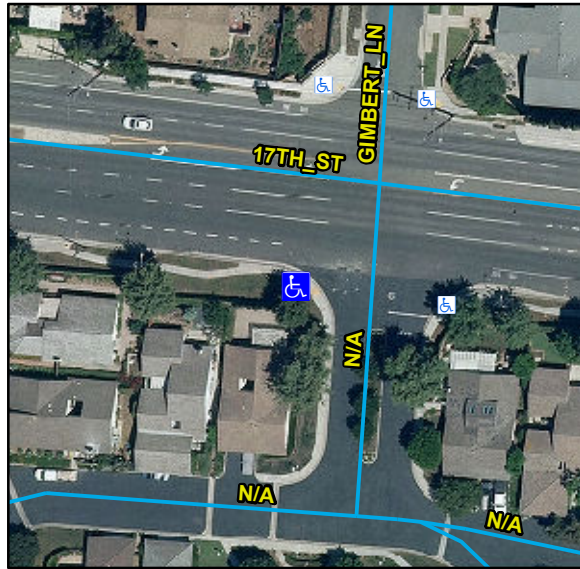
| Compliance | Description | Data | Compliance | Description | Data |
|---|---|---|---|---|---|
| No | Ramp Cross Slope LT (%) | 2.1 | Yes | Ramp Cross Slope RT (%) | 1.8 |

**Remove & Replace Curb Ramp With Two New Directional Ramps or Equivalent.**

**R304.5.3, STD 1115**
