# Access Compliance Report Public Rights-of-Way (Curb Ramps)

Main Street: JUDY\_ANNE\_LN Cross Street: NEWTON\_AVE Location: SW

ADA ID: RPRK220125133839 Ramp Type: Type 4 - Parallel Initial Pass/Fail: Fail Overall Compliance: No Severity Score: 2

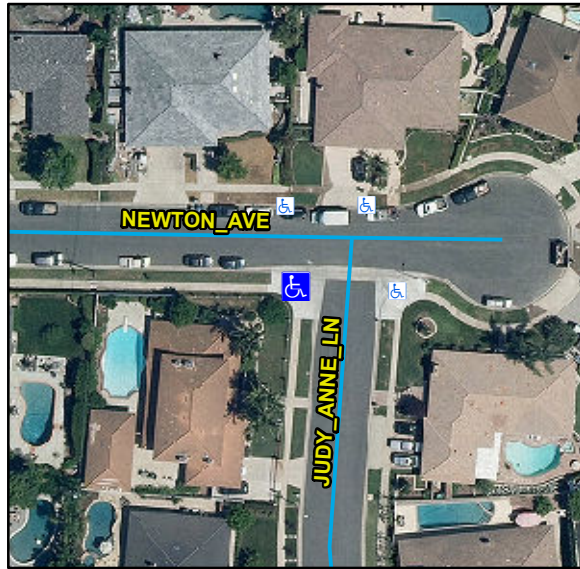
| Compliance | Description | Data | Compliance | Description | Data |
|---|---|---|---|---|---|
| No | Ramp Cross Slope LT (%) | 3.4 | No | Ramp Cross Slope RT (%) | 3.1 |

**Remove & Replace Curb Ramp With Two New Directional Ramps or Equivalent.**

**R304.5.3, STD 1115**
