# Access Compliance Report Public Rights-of-Way (Curb Ramps)

Main Street: **NEWTON\_AVE** Cross Street: **JUDY\_ANNE\_LN** Location: **SE**

ADA ID: **RPRK220125134104** Ramp Type: **Type 4 - Parallel** Initial Pass/Fail: **Fail** Overall Compliance: **No** Severity Score: **2**

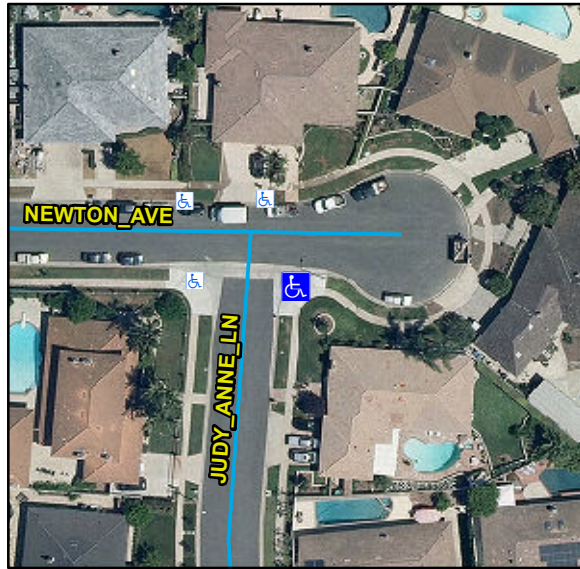
| Compliance | Description | Data | Compliance | Description | Data |
|---|---|---|---|---|---|
| <b>No</b> | Ramp Cross Slope LT (%) | <b>3.1</b> | <b>No</b> | Ramp Cross Slope RT (%) | <b>2.8</b> |

**Remove & Replace Curb Ramp With Two New Directional Ramps or Equivalent.**
