# Access Compliance Report Public Rights-of-Way (Curb Ramps)

| Main Street: JUDY_ANNE_LN | | Cross Street: CASTLEGATE_LN | | Location: | NE |
| ADA ID: RPRK220125135000 | Ramp Type: Type 4 - Parallel | Initial Pass/Fail: Fail | Overall Compliance: No | Severity Score: | 15 |

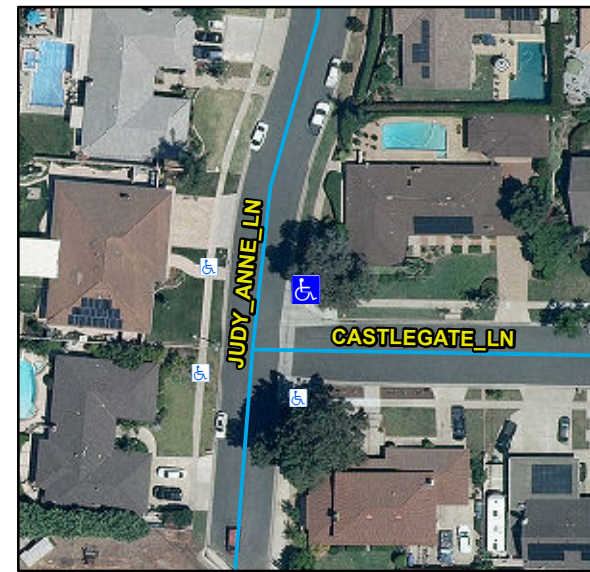
| Compliance | Description | Data | Compliance | Description | Data |
|---|---|---|---|---|---|
| No | Ramp Cross Slope LT (%) | 5.5 | No | Ramp Cross Slope RT (%) | 4.6 |

**Remove & Replace Curb Ramp With Two New Directional Ramps or Equivalent.**

**R304.5.3, STD 1115**

Total Cost: \$ 4000
