# Access Compliance Report Public Rights-of-Way (Curb Ramps)

Main Street: CASTLEGATE\_LN Cross Street: JUDY\_ANNE\_LN Location: S

ADA ID: RPRK220125135305 Ramp Type: Type 4 - Parallel Initial Pass/Fail: Fail Overall Compliance: No Severity Score: 15

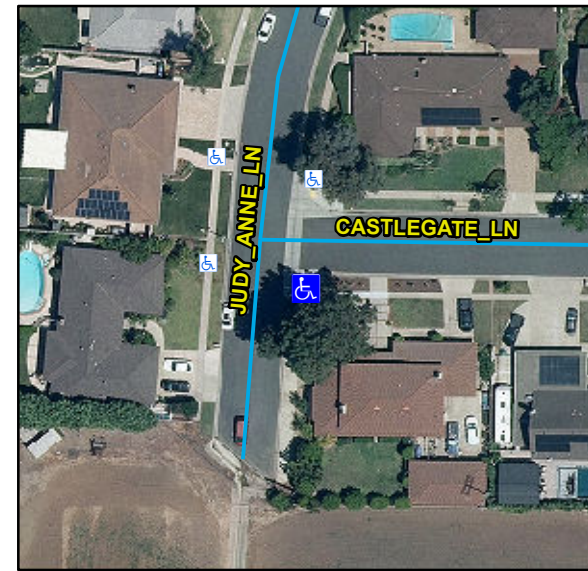
| Compliance | Description | Data | Compliance | Description | Data |
|---|---|---|---|---|---|
| No | Ramp Cross Slope LT (%) | 5 | No | Ramp Cross Slope RT (%) | 6.1 |

**Remove & Replace Curb Ramp With Two New Directional Ramps or Equivalent.**

**R304.5.3, STD 1115**
