# Access Compliance Report Public Rights-of-Way (Curb Ramps)

| Main Street: LA LIMONAR_RD | | Cross Street: NEWPORT_AVE | | Location: | S |
| ADA ID: RPRK220125135921 | Ramp Type:Type 1 - Perpendicular Diagonal Initial Pass/Fail: Fail | | Overall Compliance: No | Severity Score: | 15 |

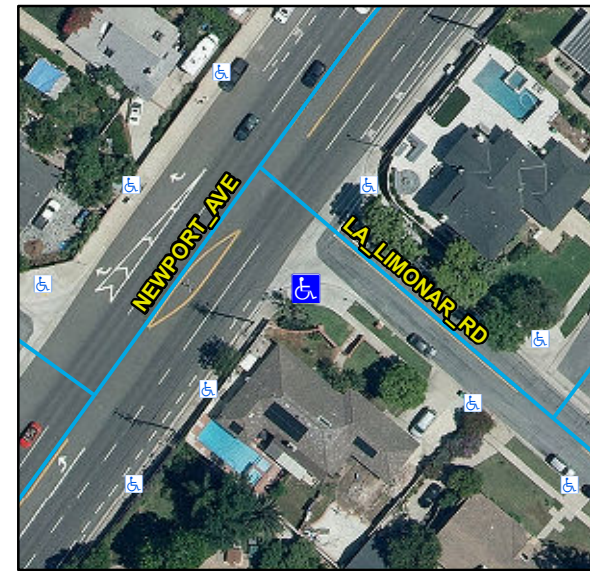
| Compliance | Description | Data | Compliance | Description | Data |
|---|---|---|---|---|---|
| No | Ramp Cross Slope (%) | 5.1 | N/A | Flare Traversable LT | N/A |

**Remove & Replace Curb Ramp With Two New Directional Ramps or Equivalent.**

**R304.5.3, STD 1115**
