# Access Compliance Report Public Rights-of-Way (Curb Ramps)

| Main Street: ARROYO_AVE | | Cross Street: TREASURE_LN | | Location: | E |
| ADA ID: RPRK220125140614 | Ramp Type: Type 4 - Parallel | Initial Pass/Fail: Fail | Overall Compliance: No | Severity Score: | 15 |

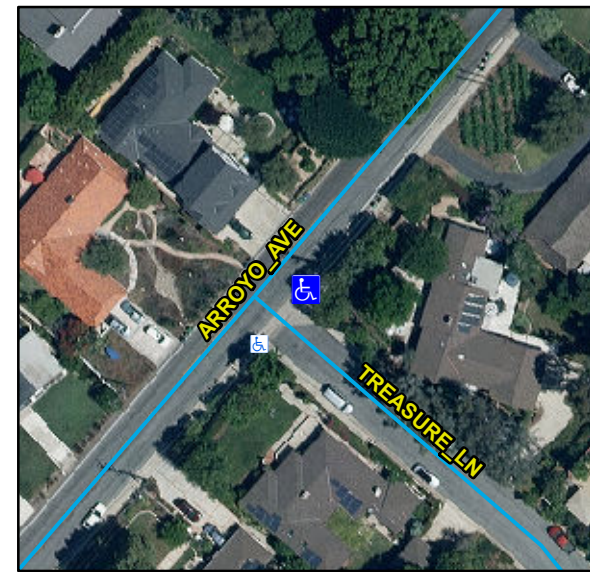
| Compliance | Description | Data | Compliance | Description | Data |
|---|---|---|---|---|---|
| Yes | Ramp Run Slope LT (%) | 8.1 | No | Ramp Run Slope RT (%) | 11.7 |

Possible Solutions:

**Remove & Replace Curb Ramp With Two New Directional Ramps or Equivalent.**

**R304.3.2, STD 1115**

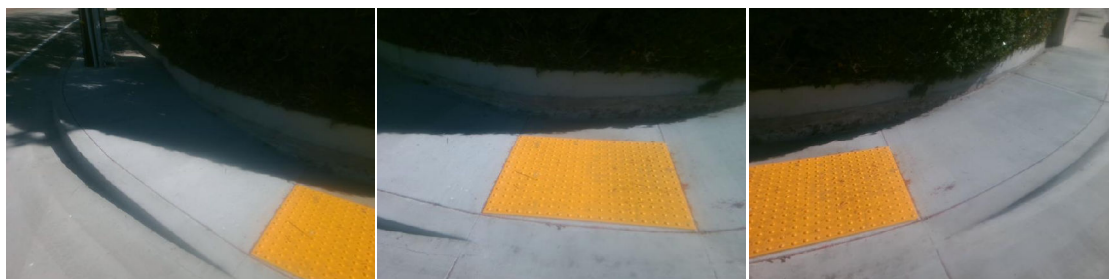
| Compliance | Description | Data | Compliance | Description | Data |
|---|---|---|---|---|---|
| N/A | Ramp Length LT (in) | 118 | N/A | Ramp Length RT (in) | 93 |
| Yes | Ramp Width LT (in) | 53 | Yes | Ramp Width RT (in) | 53 |
| Yes | Ramp Cross Slope LT (%) | 0.9 | Yes | Ramp Cross Slope RT (%) | 1.2 |
