# Access Compliance Report Public Rights-of-Way (Curb Ramps)

Main Street: GIGI\_DR Cross Street: FOOTHILL\_BLV Location: E

ADA ID: RPRK220125141240 Ramp Type: Type 4 - Parallel Initial Pass/Fail: Pass Overall Compliance: No Severity Score: 4

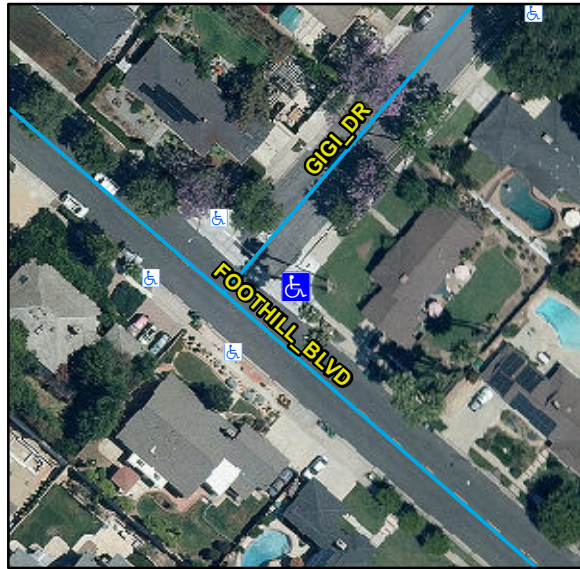
| Compliance | Description | Data | Compliance | Description | Data |
|---|---|---|---|---|---|
| No | Gutter Cross Slope (%) | 2.1 | Yes | Perpendicular Joint Present | Yes |

Remove & Replace Landing. Remove & Replace Gutter.
