# Access Compliance Report Public Rights-of-Way (Curb Ramps)

Main Street: N/A Cross Street: CRAWFORD\_CANYON\_RD Location: W

ADA ID: RPRK220126101552 Ramp Type: Type 6 - Directional 1 Initial Pass/Fail: Pass Overall Compliance: No Severity Score: 10

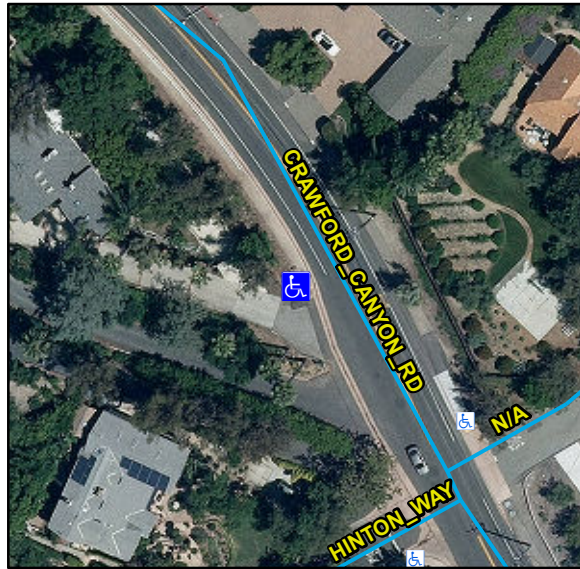
| Compliance | Description | Data | Compliance | Description | Data |
|---|---|---|---|---|---|
| N/A | Ramp Length (in) | 130 | Yes | Flare Type LT | Curbed2 |
| Yes | Ramp Run Slope (%) | 8 | N/A | Flare Slope LT (%) | N/A |
| Yes | Ramp Cross Slope (%) | 2.2 | N/A | Flare Traversable LT | N/A |
| No | Landing Length (in) | N/A | Yes | DWS Length (in) | 36 |
| No | Landing Width (in) | N/A | Yes | DWS Full Width | Yes |
| No | Landing Run Slope (%) | N/A | | DWS Offset Type | Single |
| No | Landing Cross Slope (%) | N/A | No | DWS Left Offset (in) | 24 |
| Yes | Gutter Ponding | No | No | Curb Slope | 9.6 |

Remove & Replace Entire Ramp.

R304.2.2, R204.3, R304.2.1, R304.2.2-Perp,  
R304.3.2-Para, R304.5.3, R305.2, STD 1115

Total Cost: \$ 3080
