Access Compliance Report Public Rights-of-Way (Curb Ramps)

Main Street: SKYLINE_DR **Cross Street:** NEWPORT_AVE **Location:** S

ADA ID: RPRK220126104846 **Ramp Type:** Type 4 - Parallel **Initial Pass/Fail:** Fail **Overall Compliance:** No **Severity Score:** 15

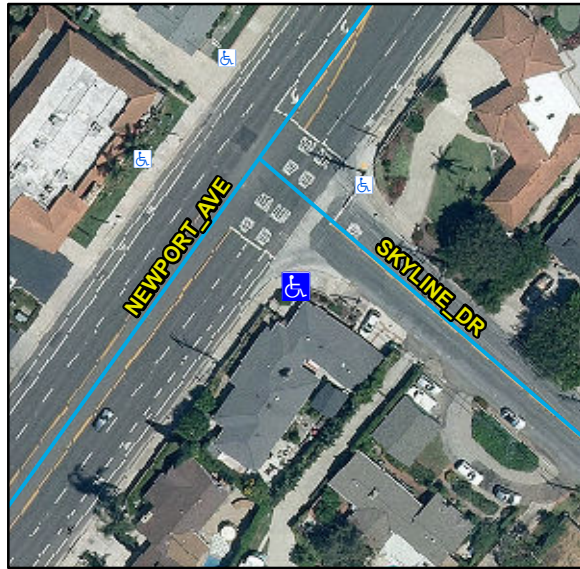
Compliance	Description	Data	Compliance	Description	Data
N/A	Ramp Length LT (in)	104	N/A	Ramp Length RT (in)	92
Yes	Ramp Width LT (in)	96	Yes	Ramp Width RT (in)	96
No	Ramp Run Slope LT (%)	9.1	Yes	Ramp Run Slope RT (%)	4.3
Yes	Ramp Cross Slope LT (%)	1.4	Yes	Ramp Cross Slope RT (%)	1.8
N/A	Landing Present	N/A	N/A	DWS Provided	N/A
N/A	Landing Length (in)	N/A	N/A	DWS Contrast	N/A
N/A	Landing Width (in)	N/A	N/A	DWS Length (in)	N/A
N/A	Landing Run Slope (%)	N/A	N/A	DWS Full Width	N/A
N/A	Landing Cross Slope (%)	N/A		DWS Offset Type	N/A
N/A	Landing Movement Obstructed?	N/A	N/A	DWS Offset Left (in)	N/A
	Landing Movement Type	N/A	N/A	DWS Offset Right (in)	N/A
N/A	Landing Shared	N/A			
N/A	Clear Space	Yes			
N/A	Clear Space To Crosswalk (in)	N/A			
N/A	Marked Crosswalk 1	No	N/A	Marked Crosswalk 2	No
	Crossing 1 Direction	NE		Crossing 2 Direction	NW
N/A	Marked Crosswalk 1 Width (in)	N/A		Marked Crosswalk 2 Width (in)	N/A

Possible Solutions:
Remove & Replace Curb Ramp With Two New Directional Ramps or Equivalent.

OC Std/PROW:
 R304.3.2, STD 1115
