# Access Compliance Report Public Rights-of-Way (Curb Ramps)

| Main Street: CASTLEGATE_LN | | Cross Street: NEWPORT_AVE | | Location: | S |
| ADA ID: RPRK220126105553 | Ramp Type: Type 4 - Parallel | Initial Pass/Fail: Pass | Overall Compliance: Yes | Severity Score: | 0 |

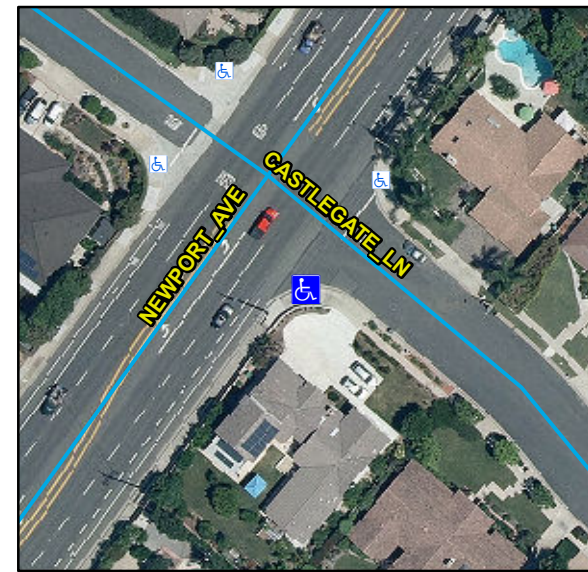
Surveyor Notes:

N/A

Possible Solutions:

N/A

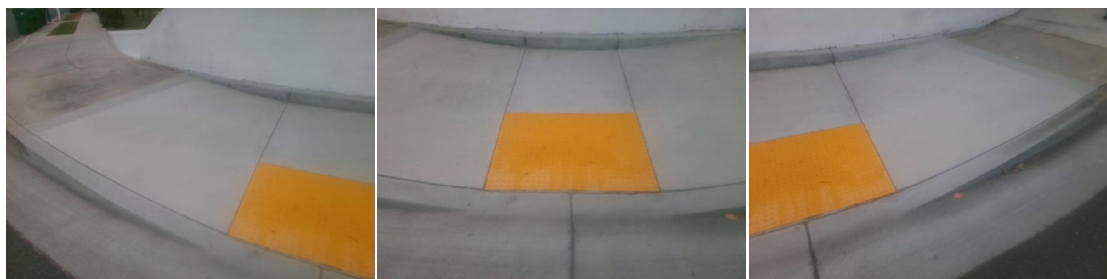
| Compliance | Description | Data | Compliance | Description | Data |
|---|---|---|---|---|---|
| N/A | Ramp Length LT (in) | 83 | N/A | Ramp Length RT (in) | 81 |
| Yes | Ramp Width LT (in) | 100 | Yes | Ramp Width RT (in) | 100 |
| Yes | Ramp Run Slope LT (%) | 4.2 | Yes | Ramp Run Slope RT (%) | 8 |
| Yes | Ramp Cross Slope LT (%) | 1.5 | Yes | Ramp Cross Slope RT (%) | 1.9 |
| Yes | Landing Width (in) | 48 | Yes | DWS Length (in) | 36 |
| Yes | Landing Run Slope (%) | 1.6 | Yes | DWS Full Width | Yes |
| Yes | Landing Cross Slope (%) | 0.4 | | DWS Offset Type | Single |
