# Access Compliance Report Public Rights-of-Way (Curb Ramps)

Main Street: TROPIC\_LN Cross Street: NEWPORT\_AVE Location: S

ADA ID: RPRK220126105949 Ramp Type: Type 4 - Parallel Initial Pass/Fail: Fail Overall Compliance: No Severity Score: 2

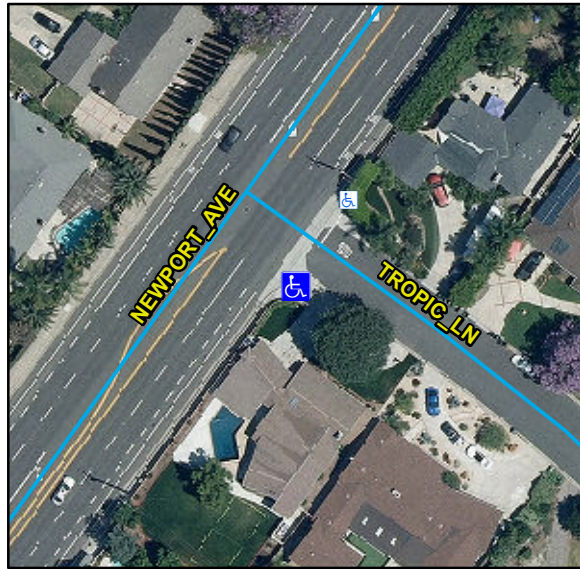
| Compliance | Description | Data | Compliance | Description | Data |
|---|---|---|---|---|---|
| No | Ramp Cross Slope LT (%) | 3.2 | Yes | Ramp Cross Slope RT (%) | 1.8 |

**Remove & Replace Curb Ramp With Two New Directional Ramps or Equivalent.**

**R304.5.3, STD 1115**

Total Cost: \$ 4000
