# Access Compliance Report Public Rights-of-Way (Curb Ramps)

| Main Street: NEWPORT_AVE | | Cross Street: TROPIC_LN | | Location: | E |
| ADA ID: RPRK220126110249 | Ramp Type: Type 4 - Parallel | Initial Pass/Fail: Fail | Overall Compliance: No | Severity Score: | 2 |

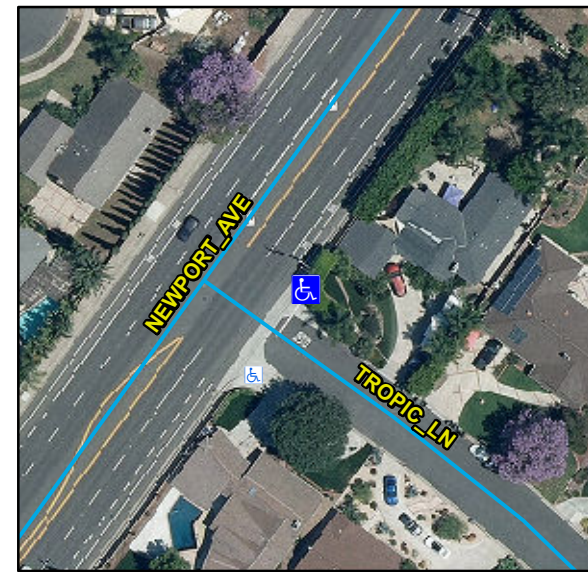
| Compliance | Description | Data | Compliance | Description | Data |
|---|---|---|---|---|---|
| Yes | Ramp Cross Slope LT (%) | 1.9 | No | Ramp Cross Slope RT (%) | 2.4 |

**Remove & Replace Curb Ramp With Two New Directional Ramps or Equivalent.**

**R304.5.3, STD 1115**

Total Cost: \$ 4000

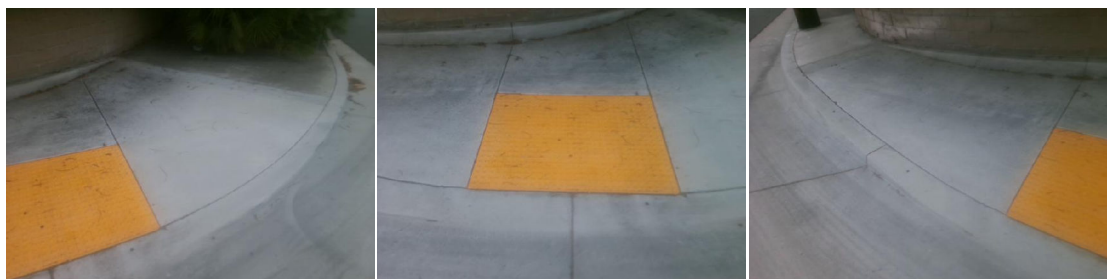
| Compliance | Description | Data | Compliance | Description | Data |
|---|---|---|---|---|---|
| N/A | Ramp Length LT (in) | 104 | N/A | Ramp Length RT (in) | 83 |
| Yes | Ramp Width LT (in) | 87 | Yes | Ramp Width RT (in) | 87 |
| Yes | Ramp Run Slope LT (%) | 6 | Yes | Ramp Run Slope RT (%) | 1.5 |
