# Access Compliance Report Public Rights-of-Way (Curb Ramps)

| Main Street: NEWPORT_AVE | | Cross Street: ST_REGIS_PL | | Location: | E |
| ADA ID: RPRK220126110526 | Ramp Type: Type 4 - Parallel | Initial Pass/Fail: Fail | Overall Compliance: No | Severity Score: | 15 |

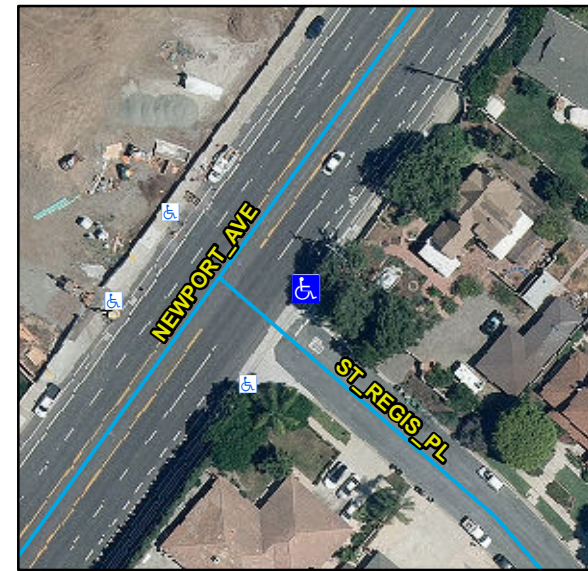
| Compliance | Description | Data | Compliance | Description | Data |
|---|---|---|---|---|---|
| Yes | Ramp Run Slope LT (%) | 8.2 | Yes | Ramp Run Slope RT (%) | 3.9 |
| No | Ramp Cross Slope LT (%) | 5.9 | Yes | Ramp Cross Slope RT (%) | 2 |

**Remove & Replace Curb Ramp With Two New Directional Ramps or Equivalent.**

**R304.5.3, STD 1115**

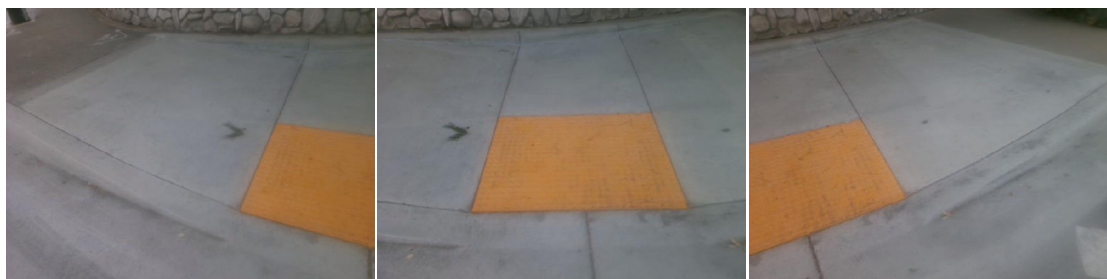
| Compliance | Description | Data | Compliance | Description | Data |
|---|---|---|---|---|---|
| N/A | Ramp Length LT (in) | 88 | N/A | Ramp Length RT (in) | 93 |
| Yes | Ramp Width LT (in) | 104 | Yes | Ramp Width RT (in) | 104 |
