# Access Compliance Report Public Rights-of-Way (Curb Ramps)

Main Street: NEWPORT\_AVE Cross Street: DODGE\_AVE Location: SE

ADA ID: RPRK220126111951 Ramp Type: Type 4 - Parallel Initial Pass/Fail: Fail Overall Compliance: No Severity Score: 2

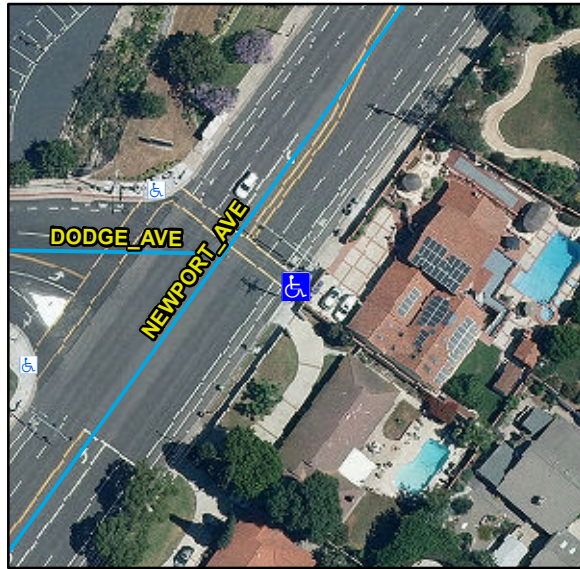
| Compliance | Description | Data | Compliance | Description | Data |
|---|---|---|---|---|---|
| Yes | Ramp Cross Slope LT (%) | 1.1 | No | Ramp Cross Slope RT (%) | 3.1 |

Remove & Replace Entire Ramp. Restripe Crosswalk.

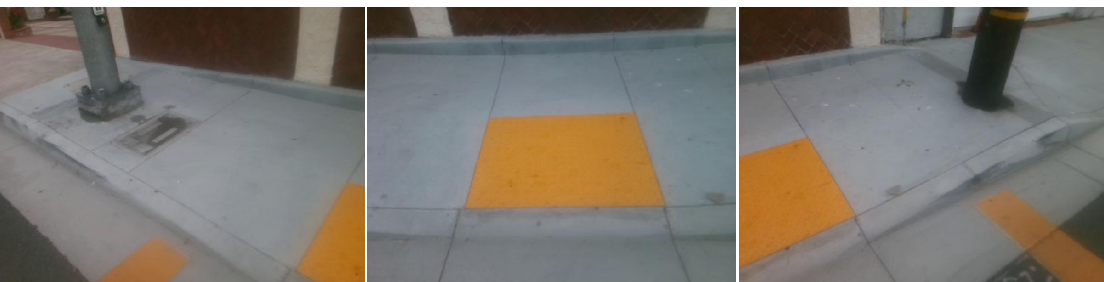
| Compliance | Description | Data | Compliance | Description | Data |
|---|---|---|---|---|---|
| No | Obstructions Present? | Yes | N/A | Utilities Present? | Yes |
| | Obstruction Types | Traffic Signal Pole | | Utility Types | |
