# Access Compliance Report Public Rights-of-Way (Curb Ramps)

| Main Street: COTTONWOOD_DR | | Cross Street: OLD_FOOTHILL_BLVD | | Location: | S |
| ADA ID: RPRK220126113453 | Ramp Type: Type 4 - Parallel | Initial Pass/Fail: Pass | Overall Compliance: No | Severity Score: | 5 |

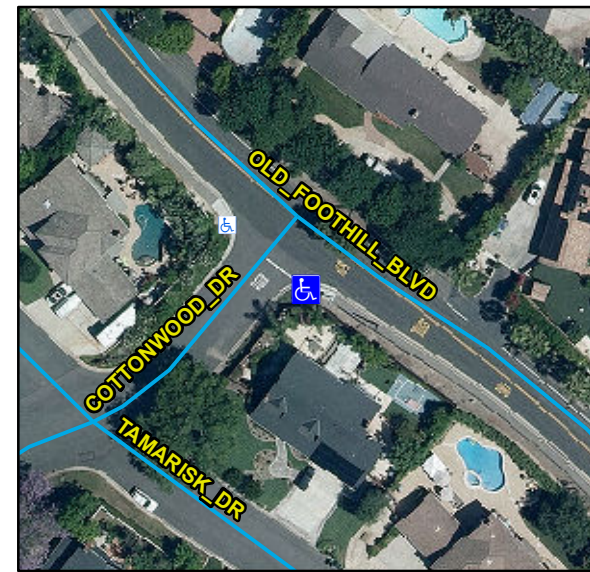
| Compliance | Description | Data | Compliance | Description | Data |
|---|---|---|---|---|---|
| N/A | Landing Movement Obstructed? | Yes | Yes | DWS Offset Left (in) | 1 |
| | Landing Movement Type | Curb | Yes | DWS Offset Right (in) | N/A |
| No | Gutter Run Slope (%) | 5.4 | | Road Cross Slope (%) | N/A |

Remove & Replace Landing. Remove & Replace Gutter.

R304.2.1, R304.5.4, STD 1115

Total Cost: \$ 783
