Access Compliance Report Public Rights-of-Way (Curb Ramps)

Main Street: COTTONWOOD_DR **Cross Street:** OLD_FOOTHILL_BLVD **Location:** W

ADA ID: RPRK220126113715 **Ramp Type:** Type 4 - Parallel **Initial Pass/Fail:** Fail **Overall Compliance:** No **Severity Score:** 30

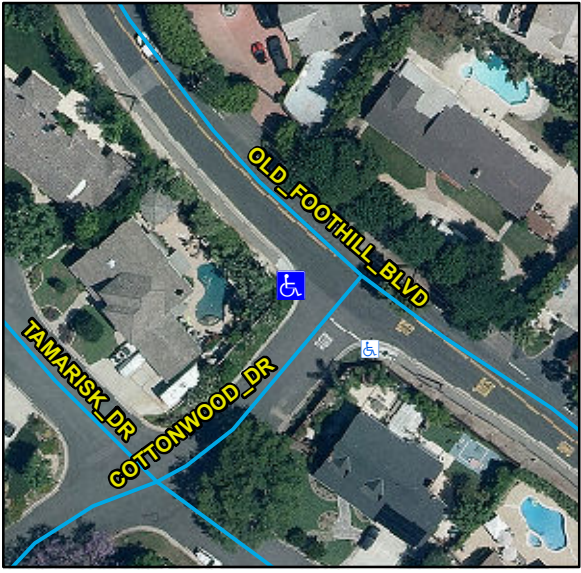
Compliance	Description	Data	Compliance	Description	Data
N/A	Ramp Length LT (in)	-9999	N/A	Ramp Length RT (in)	120
N/A	Ramp Width LT (in)	-9999	Yes	Ramp Width RT (in)	54
N/A	Ramp Run Slope LT (%)	-9999	No	Ramp Run Slope RT (%)	14.3
N/A	Ramp Cross Slope LT (%)	-9999	Yes	Ramp Cross Slope RT (%)	0.5
N/A	Landing Present	N/A	N/A	DWS Provided	N/A
N/A	Landing Length (in)	N/A	N/A	DWS Contrast	N/A
N/A	Landing Width (in)	N/A	N/A	DWS Length (in)	N/A
N/A	Landing Run Slope (%)	N/A	N/A	DWS Full Width	N/A
N/A	Landing Cross Slope (%)	N/A		DWS Offset Type	N/A
N/A	Landing Movement Obstructed?	N/A	N/A	DWS Offset Left (in)	N/A
	Landing Movement Type	N/A	N/A	DWS Offset Right (in)	N/A
N/A	Landing Shared	N/A			
N/A	Clear Space	N/A			
N/A	Clear Space To Crosswalk (in)	N/A			
N/A	Marked Crosswalk 1	No	N/A	Marked Crosswalk 2	N/A
	Crossing 1 Direction	SE		Crossing 2 Direction	N/A
	Marked Crosswalk 1 Width (in)	N/A		Marked Crosswalk 2 Width (in)	N/A

Possible Solutions:
Remove & Replace Entire Ramp.

OC Std/PROW:
R304.3.2, STD 1115

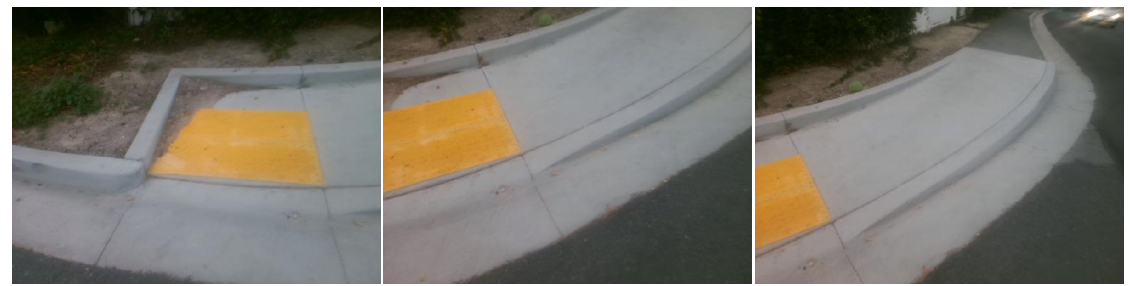
N/A	Ramp Inside Crosswalk 1	N/A	N/A	Ramp Inside Crosswalk 2	N/A
	Crossing 1 Slope (%)	5.5		Crossing 2 Slope (%)	N/A
	Crossing 1 Cross Slope (%)	8		Crossing 2 Cross Slope (%)	N/A
N/A	Gutter Ponding	N/A	N/A	Curb Slope	2.1
Yes	Gutter Lip Height (in)	0		Road Run Slope (%)	N/A
N/A	Gutter Run Slope (%)	N/A		Road Cross Slope (%)	N/A
N/A	Gutter Cross Slope (%)	N/A	Yes	Perpendicular Joint Present	Yes
Yes	Overall Surface Condition	Acceptable		Spandrel Present?	No
	Cross Gutter Present?	No		Replace Spandrel?	N/A
	Replace Cross Gutter?	N/A
