# Access Compliance Report Public Rights-of-Way (Curb Ramps)

Main Street: STANTON Cross Street: STANTON Location: NE

ADA ID: RPRK220126114243 Ramp Type: Type 4 - Parallel Initial Pass/Fail: Fail Overall Compliance: No Severity Score: 30

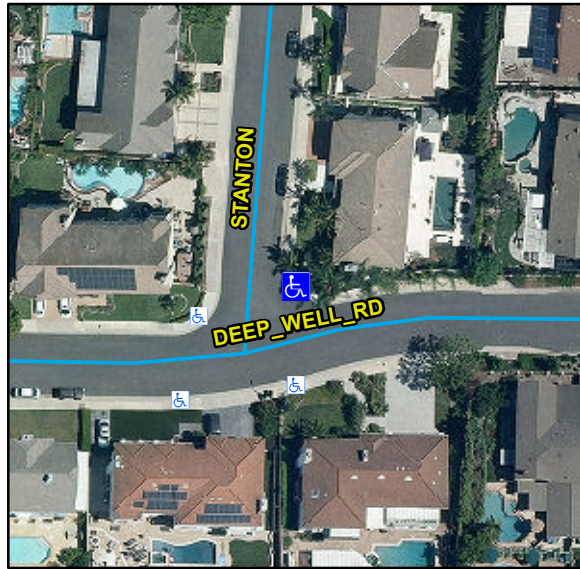
| Compliance | Description | Data | Compliance | Description | Data |
|---|---|---|---|---|---|
| Yes | Ramp Run Slope LT (%) | 2.8 | No | Ramp Run Slope RT (%) | 13.3 |

Remove & Replace Curb Ramp With Two New Directional Ramps or Equivalent.

R304.3.2, STD 1115
