# Access Compliance Report

## Public Rights-of-Way

### (Curb Ramps)

Main Street: DEEP\_WELL\_RD Cross Street: STANTON Location: NW

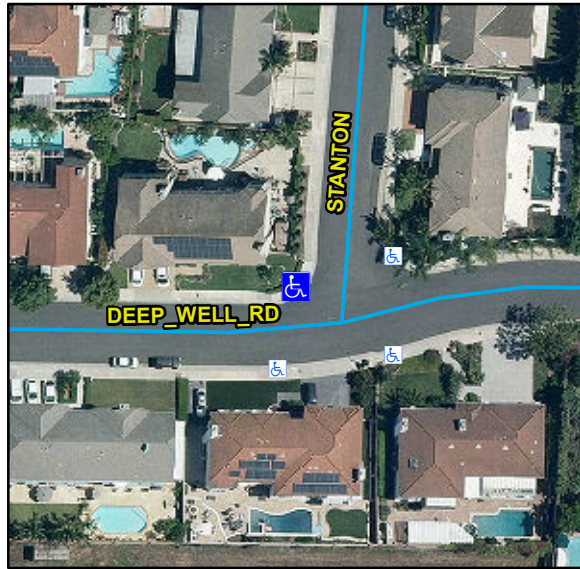
ADA ID: RPRK220126114437 Ramp Type: Type 4 - Parallel Initial Pass/Fail: Pass Overall Compliance: Yes Severity Score: 0

| Compliance | Description | Data | Compliance | Description | Data |
|---|---|---|---|---|---|
| N/A | Ramp Length LT (in) | 74 | N/A | Ramp Length RT (in) | 72 |
| Yes | Ramp Width LT (in) | 54 | Yes | Ramp Width RT (in) | 54 |
| Yes | Ramp Run Slope LT (%) | 5.9 | Yes | Ramp Run Slope RT (%) | 7.7 |
| Yes | Ramp Cross Slope LT (%) | 1.1 | Yes | Ramp Cross Slope RT (%) | 0.6 |
| Yes | Overall Surface Condition | Acceptable | | | |

Possible Solutions:

N/A
