# Access Compliance Report Public Rights-of-Way (Curb Ramps)

Main Street: LARIAT\_LN Cross Street: DEEP\_WELL\_RD Location: NE

ADA ID: RPRK220126114724 Ramp Type: Type 4 - Parallel Initial Pass/Fail: Pass Overall Compliance: No Severity Score: 5

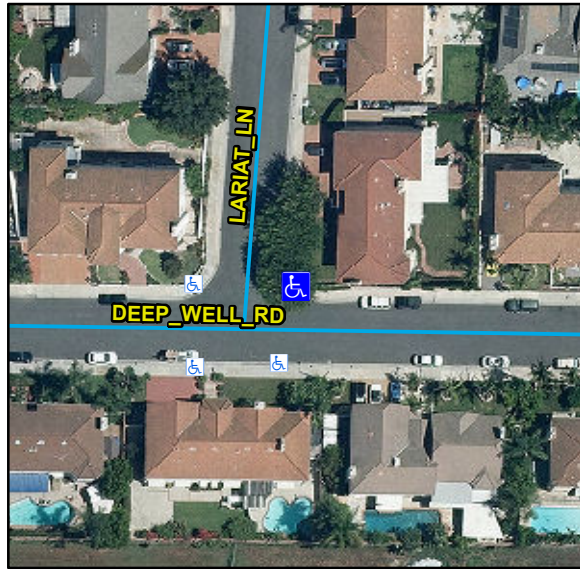
| Compliance | Description | Data | Compliance | Description | Data |
|---|---|---|---|---|---|
| No | Gutter Run Slope (%) | 5.9 | | Road Cross Slope (%) | 1.8 |
| No | Gutter Cross Slope (%) | 2.7 | Yes | Perpendicular Joint Present | Yes |

Remove & Replace Gutter.
