# Access Compliance Report Public Rights-of-Way (Curb Ramps)

Main Street: DEEP\_WELL\_RD Cross Street: LARIAT\_LN Location: NW

ADA ID: RPRK220126115212 Ramp Type: Type 4 - Parallel Initial Pass/Fail: Fail Overall Compliance: No Severity Score: 2

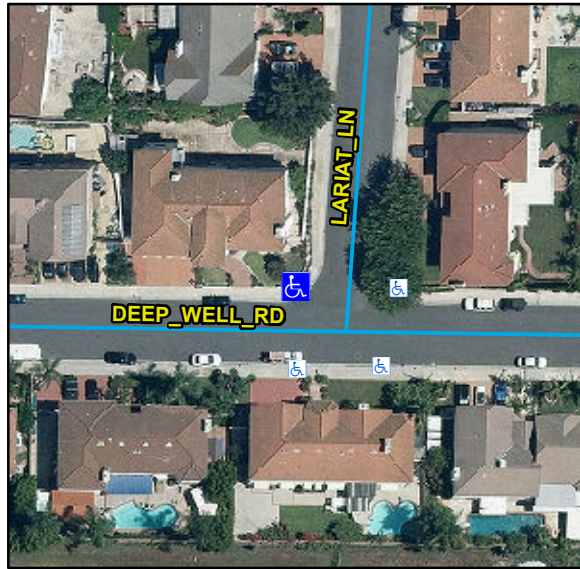
| Compliance | Description | Data | Compliance | Description | Data |
|---|---|---|---|---|---|
| No | Ramp Cross Slope LT (%) | 2.3 | Yes | Ramp Cross Slope RT (%) | 0.2 |

Remove & Replace Curb Ramp With Two New Directional Ramps or Equivalent.

R304.5.3, STD 1115
