# Access Compliance Report Public Rights-of-Way (Curb Ramps)

Main Street: SCOTT Cross Street: DEEP\_WELL\_RD Location: NE

ADA ID: RPRK220126115417 Ramp Type: Type 4 - Parallel Initial Pass/Fail: Pass Overall Compliance: No Severity Score: 5

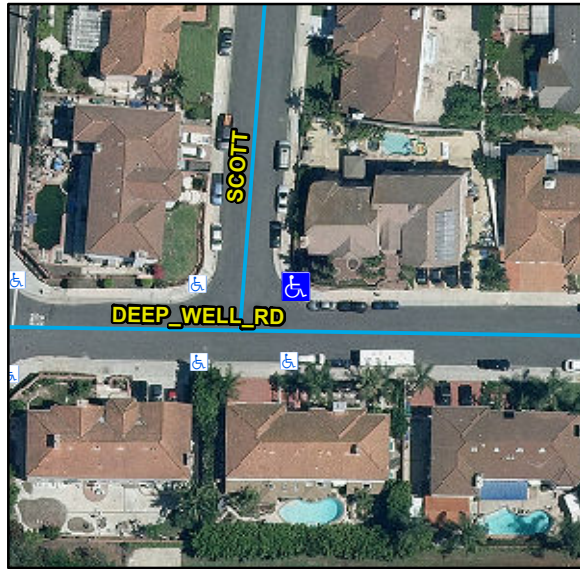
| Compliance | Description | Data | Compliance | Description | Data |
|---|---|---|---|---|---|
| No | Gutter Run Slope (%) | 9.1 | | Road Cross Slope (%) | 3.2 |

Remove & Replace Gutter.

R304.5.4, STD 1115
