Access Compliance Report Public Rights-of-Way (Curb Ramps)

Main Street: DEEP WELL RD **Cross Street: SCOTT** Location: NW ADA ID: RPRK220126115809 Ramp Type: Type 4 - Parallel **Initial Pass/Fail: Pass Overall Compliance: Yes Severity Score:**

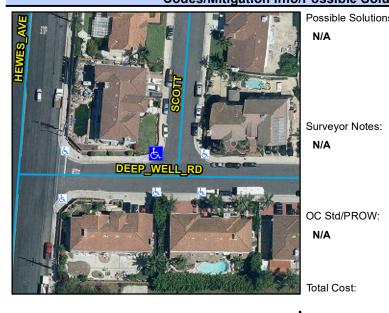
Field Measurements/Component Compliance									
	Com	pliance Description	Data	Com	pliance Description	Data			
	N/A	Ramp Length LT (in)	64	N/A	Ramp Length RT (in)	78			
	Yes	Ramp Width LT (in)	54	Yes	Ramp Width RT (in)	54			
	Yes	Ramp Run Slope LT (%)	5.7	Yes	Ramp Run Slope RT (%)	6.1			
	Yes	Ramp Cross Slope LT (%)	1.2	Yes	Ramp Cross Slope RT (%)	1.7			
	N/A	Landing Present	Yes	Yes	DWS Provided	Yes			
	N/A	Landing Length (in)	54	Yes	DWS Contrast	Yes			
	Yes	Landing Width (in)	48	Yes	DWS Length (in)	36			
	Yes	Landing Run Slope (%)	0.2	Yes	DWS Full Width	Yes			
	Yes	Landing Cross Slope (%)	0.5		DWS Offset Type	Single			
	N/A	Landing Movement Obstructed?	No	Yes	DWS Offset Left (in)	0			
		Landing Movement Type	Curb	Yes	DWS Offset Right (in)	N/A			
	N/A	Landing Shared	No						
	N/A	Clear Space	Yes						
	N/A	Clear Space To Crosswalk (in)	48						
)	N/A	Marked Crosswalk 1	No	N/A	Marked Crosswalk 2	No			
		Crossing 1 Direction	S		Crossing 2 Direction	E

)		Marked Crosswalk 1 Width (in)	N/A		Marked Crosswalk 2 Width (in)	N/A			
ı	N/A	Ramp Inside Crosswalk 1	N/A	N/A	Ramp Inside Crosswalk 2	N/A			
Г		Crossing 1 Slope (%)	3.3		Crossing 2 Slope (%)	4.6			
ı		Crossing 1 Cross Slope (%)	0		Crossing 2 Cross Slope (%)	0.7			
	Yes	Gutter Ponding	No	Yes	Curb Slope	5.8			
	Yes	Gutter Lip Height (in)	0		Road Run Slope (%)	0.1			
	Yes	Gutter Run Slope (%)	4.5		Road Cross Slope (%)	7.1

-	Yes	Gutter Cross Slope (%)	1.3	Yes	Perpendicular Joint Present	Yes			
1	Yes	Overall Surface Condition Accep	otable						
		Cross Gutter Present?	No		Spandrel Present?	No			
`		Replace Cross Gutter?	N/A		Replace Spandrel?	N/A
