# Access Compliance Report Public Rights-of-Way (Curb Ramps)

Main Street: HEWES\_AVE Cross Street: DEEP\_WELL\_RD Location: NE

ADA ID: RPRK220126120056 Ramp Type: Type 4 - Parallel Initial Pass/Fail: Fail Overall Compliance: No Severity Score: 30

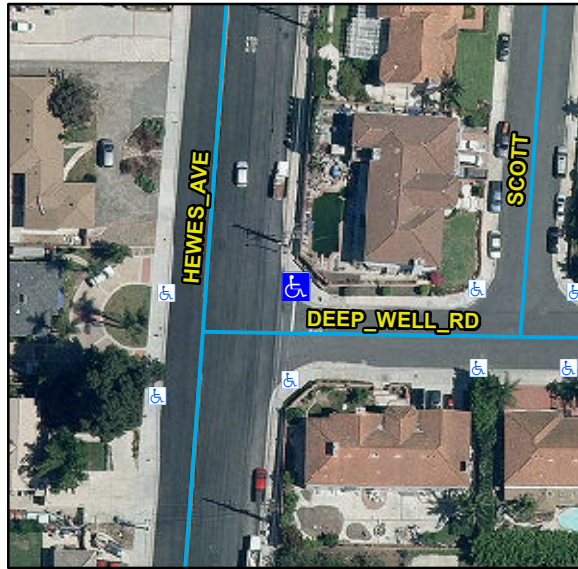
| Compliance | Description | Data | Compliance | Description | Data |
|---|---|---|---|---|---|
| No | Ramp Run Slope LT (%) | 12.6 | Yes | Ramp Run Slope RT (%) | 5 |

**Remove & Replace Curb Ramp With Two New Directional Ramps or Equivalent.**

**R304.3.2, STD 1115**
