# Access Compliance Report Public Rights-of-Way (Curb Ramps)

Main Street: DEEP\_WELL\_RD Cross Street: HEWES\_AVE Location: SE

ADA ID: RPRK220126120342 Ramp Type: Type 4 - Parallel Initial Pass/Fail: Pass Overall Compliance: No Severity Score: 2

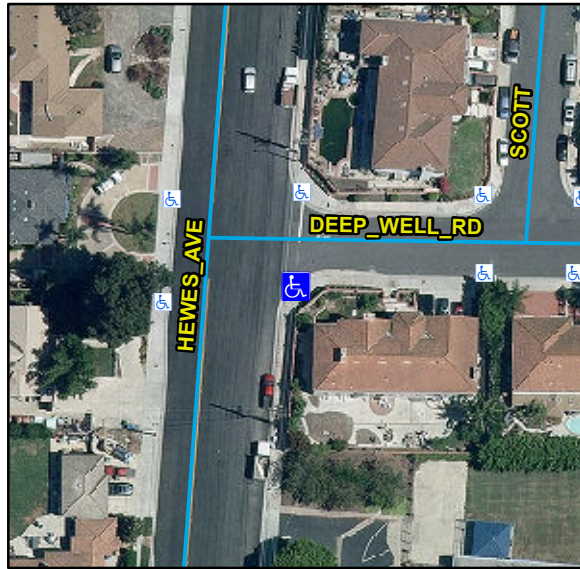
| Compliance | Description | Data | Compliance | Description | Data |
|---|---|---|---|---|---|
| No | Landing Run Slope (%) | 2.5 | Yes | DWS Full Width | Yes |

Remove & Replace Landing.
