# Access Compliance Report Public Rights-of-Way (Curb Ramps)

Main Street: E\_ROMELLE\_AVE Cross Street: YORBA\_ST Location: SE

ADA ID: RPRK220126121217 Ramp Type: Type 1 - Perpendicular Diagonal Initial Pass/Fail: Fail Overall Compliance: No Severity Score: 15

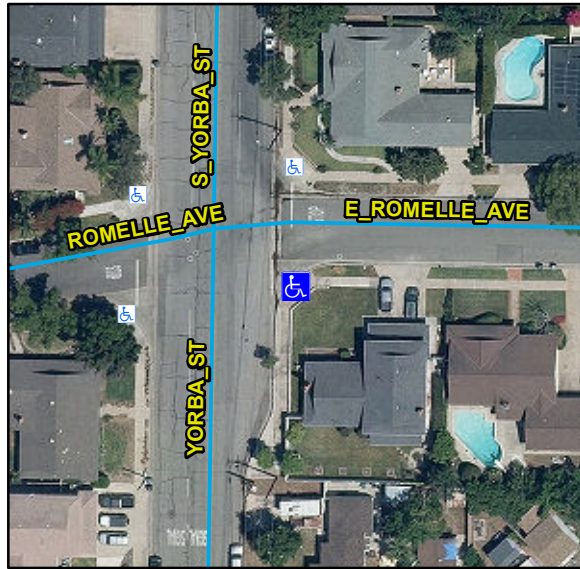
| Compliance | Description | Data | Compliance | Description | Data |
|---|---|---|---|---|---|
| No | Ramp Run Slope (%) | 8.4 | N/A | Flare Slope LT (%) | N/A |

**Remove & Replace Curb Ramp With Two New Directional Ramps or Equivalent.**

**R304.2.2, R204.3, STD 1115**
