# Access Compliance Report Public Rights-of-Way (Curb Ramps)

Main Street: ROMELLE\_AVE Cross Street: YORBA\_ST Location: NW

ADA ID: RPRK220126121601 Ramp Type: Type 1 - Perpendicular Diagonal Initial Pass/Fail: Fail Overall Compliance: No Severity Score: 16

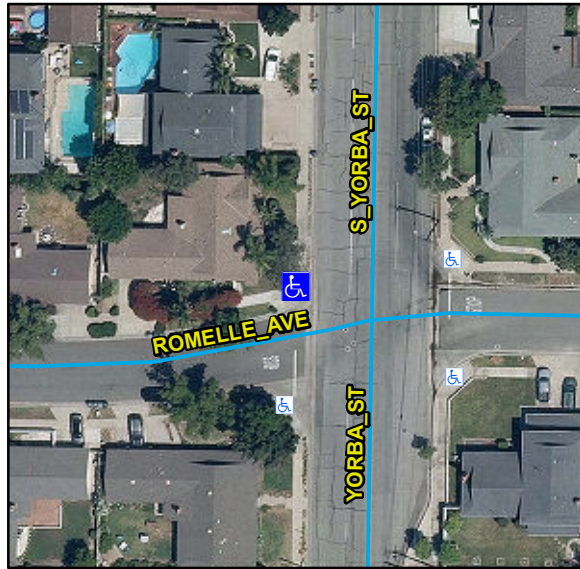
| Compliance | Description | Data | Compliance | Description | Data |
|---|---|---|---|---|---|
| No | Ramp Run Slope (%) | 10 | N/A | Flare Slope LT (%) | N/A |

**Remove & Replace Curb Ramp With Two New Directional Ramps or Equivalent.**

**R304.2.2, STD 1115**
