# Access Compliance Report Public Rights-of-Way (Curb Ramps)

Main Street: YORBA\_ST Cross Street: ROMELLE\_AVE Location: SW

ADA ID: RPRK220126121753 Ramp Type: Type 1 - Perpendicular Diagonal Initial Pass/Fail: Fail Overall Compliance: No Severity Score: 15

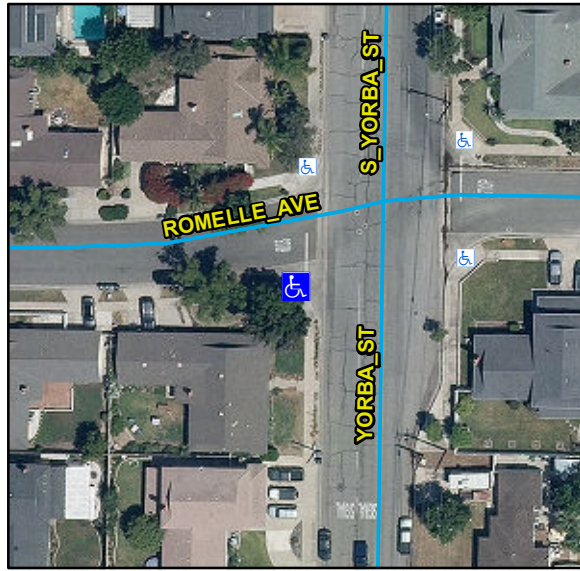
| Compliance | Description | Data | Compliance | Description | Data |
|---|---|---|---|---|---|
| No | Ramp Run Slope (%) | 9.8 | N/A | Flare Slope LT (%) | N/A |

**Remove & Replace Curb Ramp With Two New Directional Ramps or Equivalent.**

**R304.2.2, STD 1115**
