# Access Compliance Report Public Rights-of-Way (Curb Ramps)

Main Street: FAIRHAVEN\_AVE Cross Street: YORBA\_ST Location: NW

ADA ID: RPRK220126122143 Ramp Type: Type 1 - Perpendicular Diagonal Initial Pass/Fail: Fail Overall Compliance: No Severity Score: 16

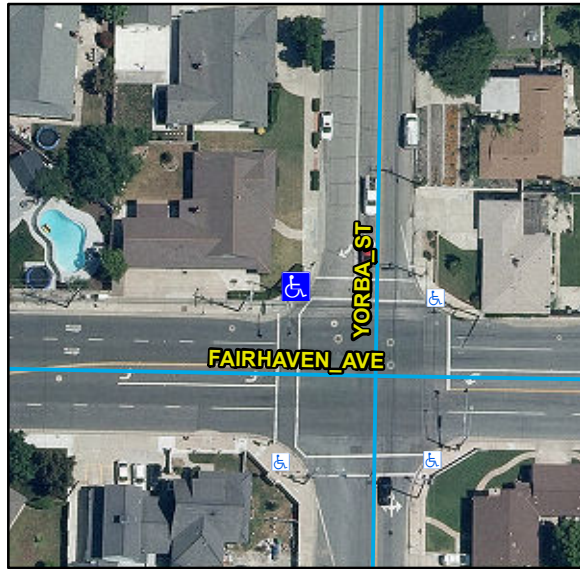
| Compliance | Description | Data | Compliance | Description | Data |
|---|---|---|---|---|---|
| No | Ramp Run Slope (%) | 11.8 | N/A | Flare Slope LT (%) | N/A |
| No | Gutter Lip Height (in) | 0.5 | | Road Run Slope (%) | 0.7 |

**Remove & Replace Curb Ramp With Two New Directional Ramps or Equivalent. Grind Gutter Lip.**

**R204.3, R304.2.2, R302.7.2, STD 1115**
