# Access Compliance Report Public Rights-of-Way (Curb Ramps)

Main Street: YORBA\_ST Cross Street: FAIRHAVEN\_AVE Location: SW

ADA ID: RPRK220126122655 Ramp Type: Type 1 - Perpendicular Diagonal Initial Pass/Fail: Fail Overall Compliance: No Severity Score: 30

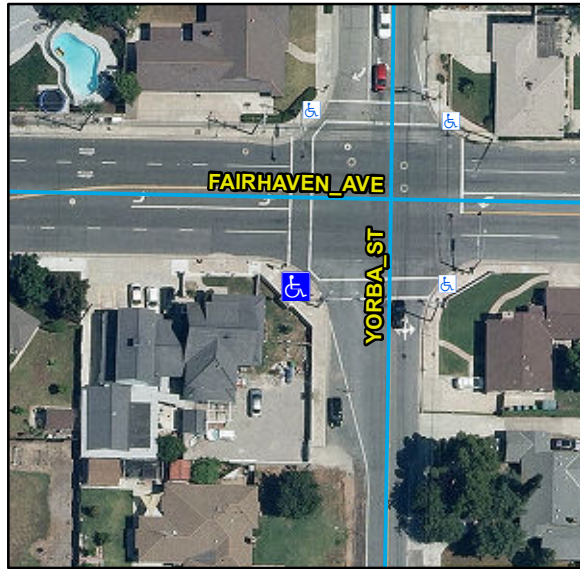
| Compliance | Description | Data | Compliance | Description | Data |
|---|---|---|---|---|---|
| No | Ramp Run Slope (%) | 11.7 | N/A | Flare Slope LT (%) | N/A |
| No | Ramp Cross Slope (%) | 5.5 | N/A | Flare Traversable LT | N/A |
| No | Gutter Lip Height (in) | 1.5 | | Road Run Slope (%) | 1 |

Remove & Replace Curb Ramp With Two New Directional Ramps or Equivalent.
