# Access Compliance Report

## Public Rights-of-Way

### (Curb Ramps)

Main Street: FAIRHAVEN\_AVE Cross Street: YORBA\_ST Location: SE

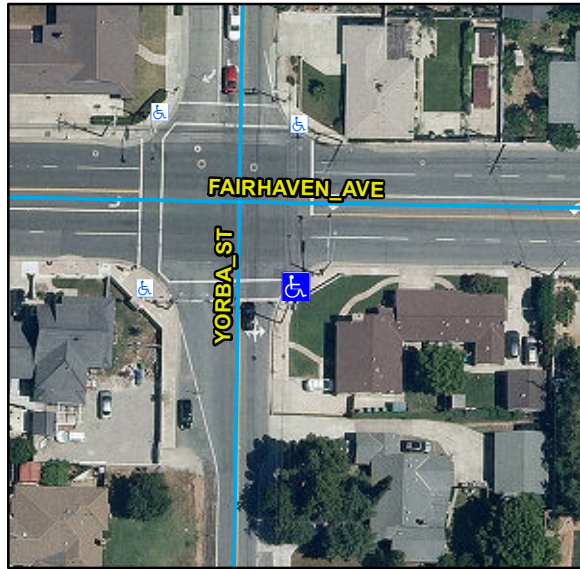
ADA ID: RPRK220126123140 Ramp Type: Type 1 - Perpendicular Diagonal Initial Pass/Fail: Fail Overall Compliance: No Severity Score: 15

| Compliance | Description | Data | Compliance | Description | Data |
|---|---|---|---|---|---|
| No | Ramp Run Slope (%) | 11.2 | N/A | Flare Slope LT (%) | N/A |
| No | Gutter Lip Height (in) | 0.25 | | Road Run Slope (%) | 1.4 |

**Remove & Replace Curb Ramp With Two New Directional Ramps or Equivalent. Grind Gutter Lip.**

**R204.3, R304.2.2, R302.7.2, STD 1115**
