# Access Compliance Report Public Rights-of-Way (Curb Ramps)

Main Street: YORBA\_ST Cross Street: FAIRHAVEN\_AVE Location: NE

ADA ID: RPRK220126123507 Ramp Type: Type 1 - Perpendicular Diagonal Initial Pass/Fail: Fail Overall Compliance: No Severity Score: 16

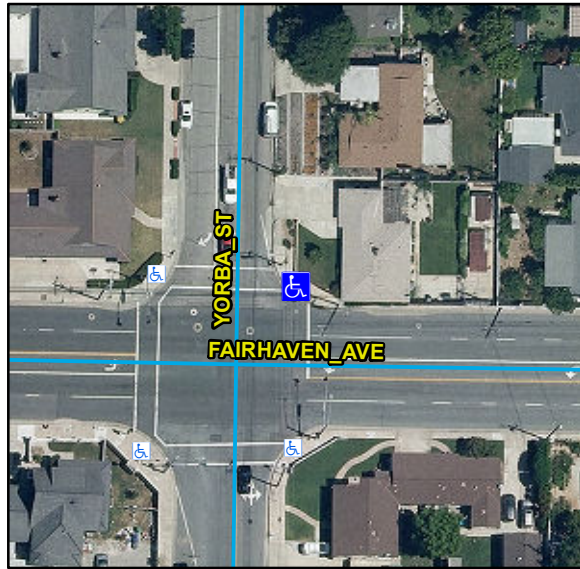
| Compliance | Description | Data | Compliance | Description | Data |
|---|---|---|---|---|---|
| No | Ramp Run Slope (%) | 9.1 | N/A | Flare Slope LT (%) | N/A |
| N/A | Gutter Ponding | N/A | No | Curb Slope | 10.1 |
| No | Gutter Lip Height (in) | 0.5 | | Road Run Slope (%) | 0.1 |

**Remove & Replace Curb Ramp With Two New Directional Ramps or Equivalent. Restripe Crosswalk.**

**R304.2.2, R204.3, R302.7.2, STD 1115**
