# Access Compliance Report Public Rights-of-Way (Curb Ramps)

Main Street: FAIRMONT\_WAY Cross Street: FAIRHAVEN\_AVE Location: SW

ADA ID: RPRK220127114021 Ramp Type: Type 4 - Parallel Initial Pass/Fail: Fail Overall Compliance: No Severity Score: 16

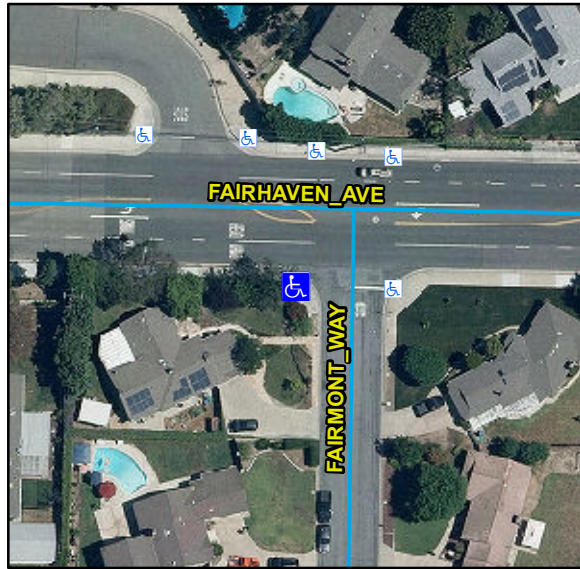
| Compliance | Description | Data | Compliance | Description | Data |
|---|---|---|---|---|---|
| No | Ramp Run Slope LT (%) | 9.9 | Yes | Ramp Run Slope RT (%) | 6.9 |
| No | Ramp Cross Slope LT (%) | 2.8 | No | Ramp Cross Slope RT (%) | 2.8 |
| No | Gutter Lip Height (in) | 0.25 | | Road Run Slope (%) | 0.6 |

Remove & Replace Curb Ramp With Two New Directional Ramps or Equivalent. Grind Gutter Lip.

R304.3.2, R304.5.3, R302.7.2, STD 1115
