# Access Compliance Report Public Rights-of-Way (Curb Ramps)

Main Street: FAIRHAVEN\_AVE Cross Street: ETHELBEE\_WAY Location: SE

ADA ID: RPRK220127114320 Ramp Type: Type 1 - Perpendicular Diagonal Initial Pass/Fail: Fail Overall Compliance: No Severity Score: 2

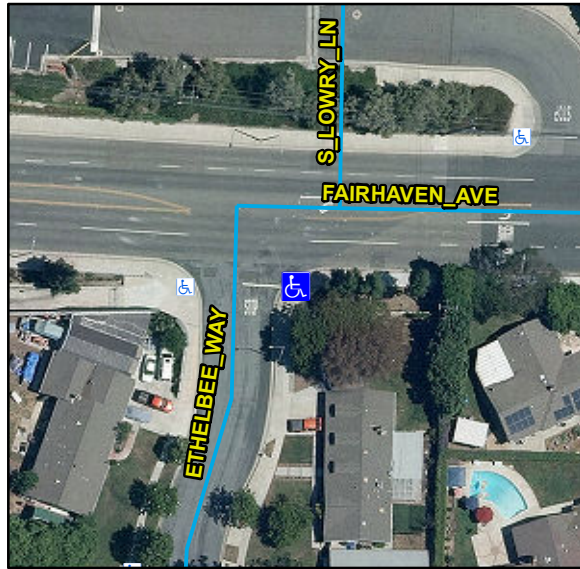
| Compliance | Description | Data | Compliance | Description | Data |
|---|---|---|---|---|---|
| No | Ramp Cross Slope (%) | 3.8 | N/A | Flare Traversable LT | N/A |

Remove & Replace Curb Ramp With Two New Directional Ramps or Equivalent.

R204.3, R304.5.3, STD 1115
