# Access Compliance Report Public Rights-of-Way (Curb Ramps)

Main Street: ETHELBEE\_WAY Cross Street: FAIRHAVEN\_AVE Location: SW

ADA ID: RPRK220127114544 Ramp Type: Type 4 - Parallel Initial Pass/Fail: Fail Overall Compliance: No Severity Score: 45

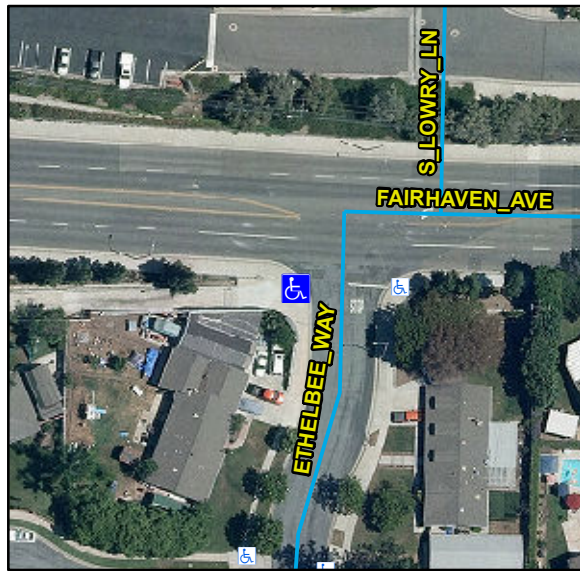
| Compliance | Description | Data | Compliance | Description | Data |
|---|---|---|---|---|---|
| No | Ramp Run Slope LT (%) | 8.9 | Yes | Ramp Run Slope RT (%) | 8.2 |
| No | Ramp Cross Slope LT (%) | 6.1 | No | Ramp Cross Slope RT (%) | 7.5 |
| No | Gutter Lip Height (in) | 0.5 | | Road Run Slope (%) | 4.6 |

Remove & Replace Curb Ramp With Two New Directional Ramps or Equivalent. Grind Gutter Lip.

R204.3, R304.3.2, R304.5.3, R302.7.2, STD 1115
