# Access Compliance Report Public Rights-of-Way (Curb Ramps)

Main Street: SANTA\_CLARA\_AVE Cross Street: FAIRMONT\_WAY Location: NW

ADA ID: RPRK220127115307 Ramp Type: Type 4 - Parallel Initial Pass/Fail: Fail Overall Compliance: No Severity Score: 15

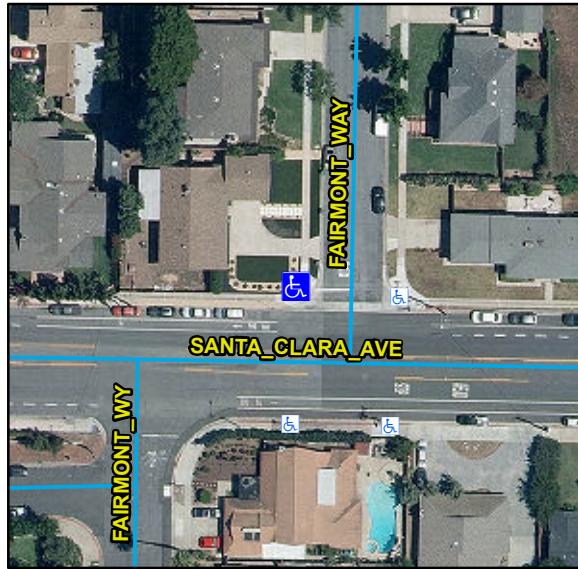
| Compliance | Description | Data | Compliance | Description | Data |
|---|---|---|---|---|---|
| No | Ramp Cross Slope LT (%) | 5.7 | No | Ramp Cross Slope RT (%) | 5.3 |

Remove & Replace Curb Ramp With Two New Directional Ramps or Equivalent.

R304.5.3, STD 1115
